The simplified diagrams below show how a Socket & See VIP ESI two pole tester may be used during a meter change and what indications could be expected under different conditions.

All diagrams show the installation being supplied by a TN-C-S system and the cut out fuse removed.

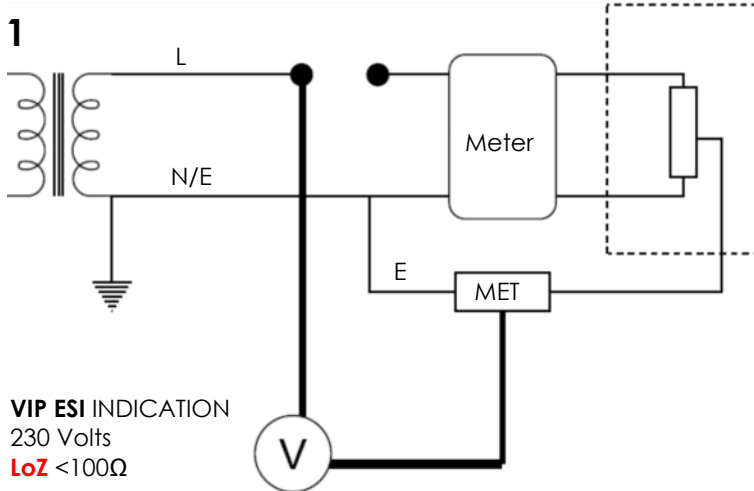
Diagram 1 shows the VIP ESI with the main probe on the network side of the cut out fuse carrier and the passive probe is on the Main Earth Terminal (MET).

The engineer would expect a voltage indication of 230V and a LoZ Light. The Low impedance measured is the earth fault loop.

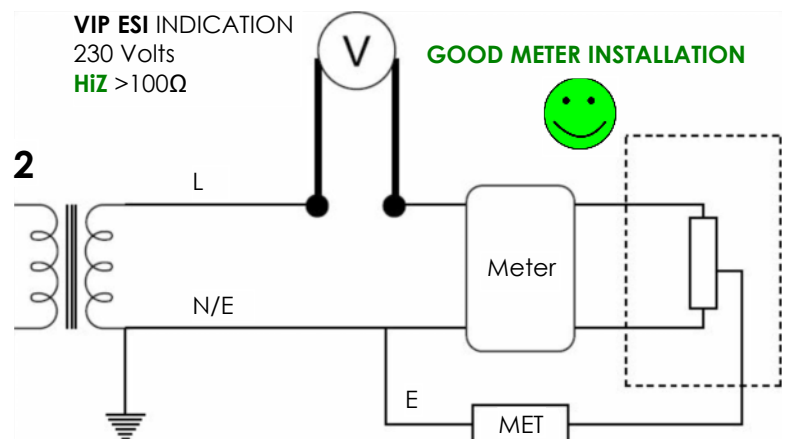
Diagram 2 shows the VIP ESI with the main probe on the network side of the fuse carrier and the passive probe on the meter side of the fuse carrier (fuse removed).

If the installed meter has been fitted correctly and there is no damage to any cables the engineer would expect a reading of 230V and a **GREEN HiZ** Light.

This HiZ indication gives the engineer the piece of mind that there is no low impedance fault and that the cut out fuse can be refitted.

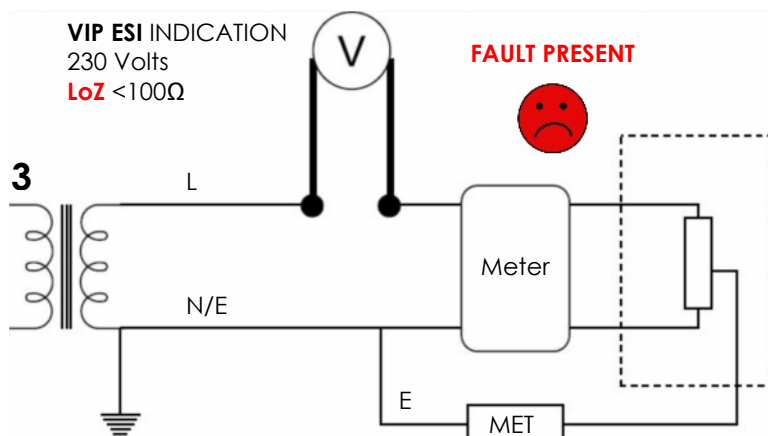
Diagram 3 shows the VIP ESI in the same position as diagram 2 but in this case the meter installation has caused a low impedance fault (short circuit). Possibly caused by trapped / chaffing cables or cables that have come loose and made contact with the metal fuse box during the meter installation.

In the case of a low impedance fault the engineer would see a voltage indication of 230V and a **RED LoZ** Light.

This LoZ indication tells the engineer that it is not safe to refit the fuse as a potentially dangerous high fault current would flow. Further investigation would be required.
